LAKE-SUMTER MPO VISION ZERO ACTION PLAN

Draft Plan

Vision Zero Action Plan (VZAP)

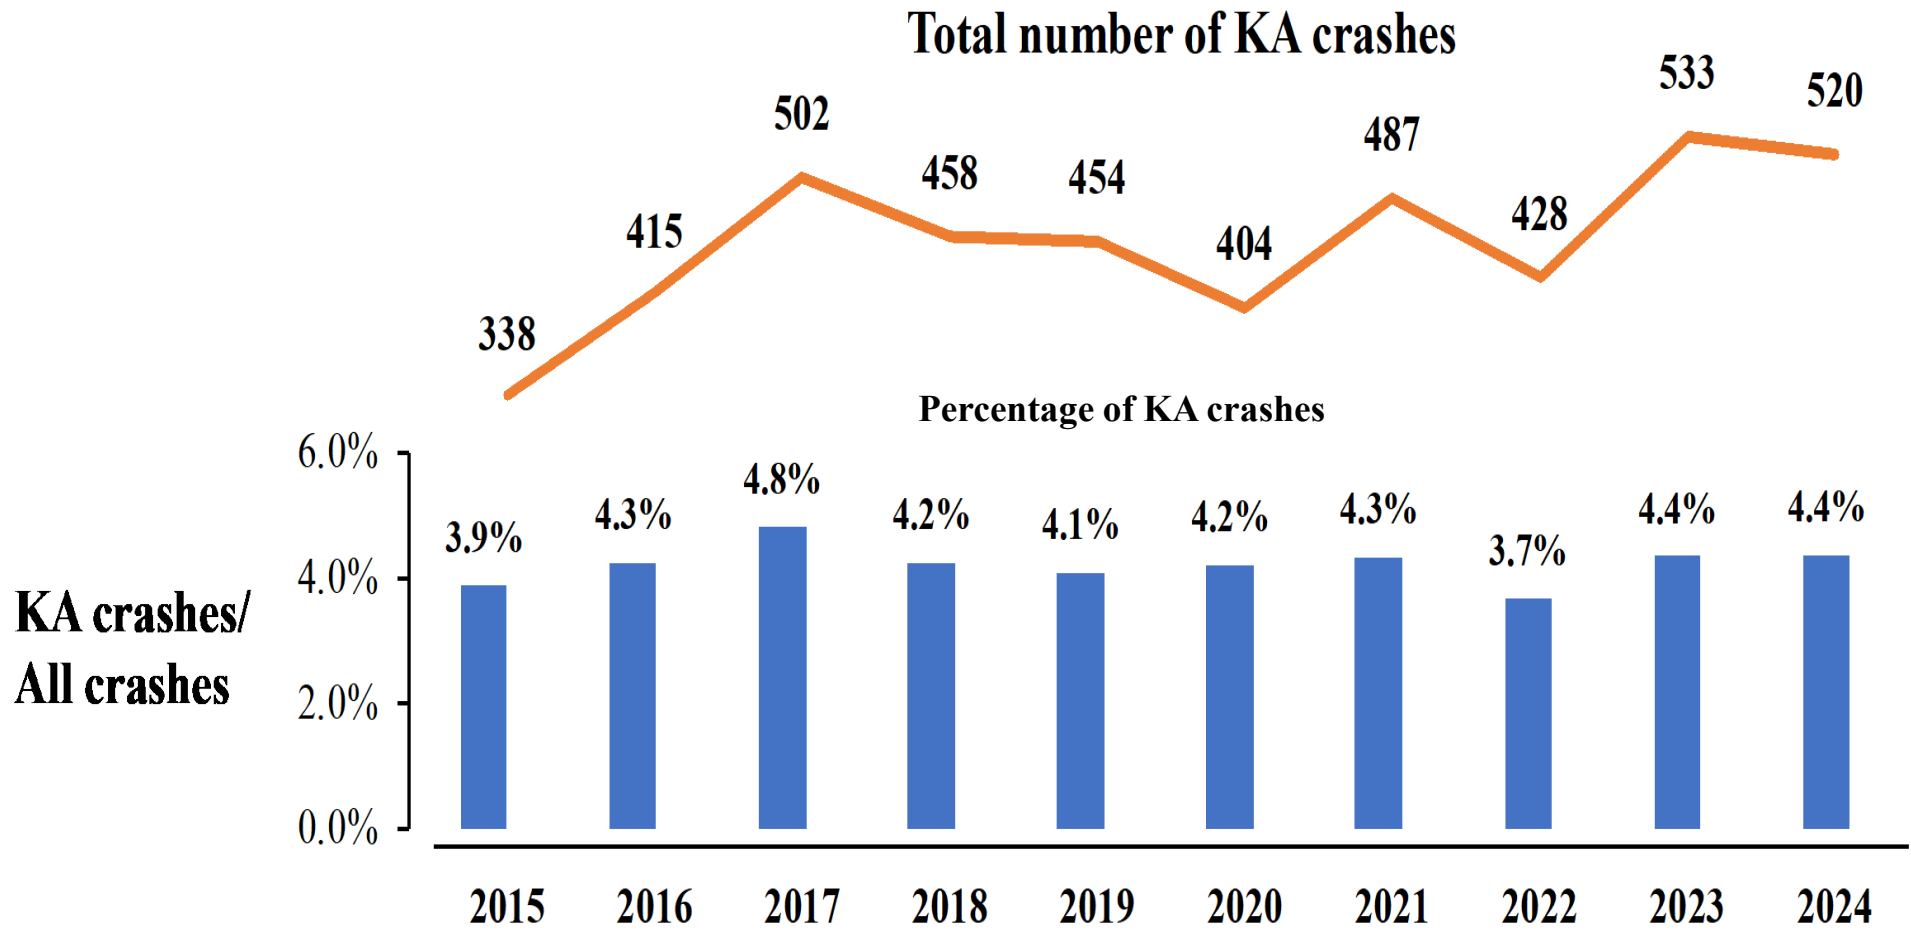
Ten-years trend for KA crashes

- Note:**
- State of Florida 10-year KA crash rate is 2.4%
 - Orange County 5-year KA crash rate is 3.1%

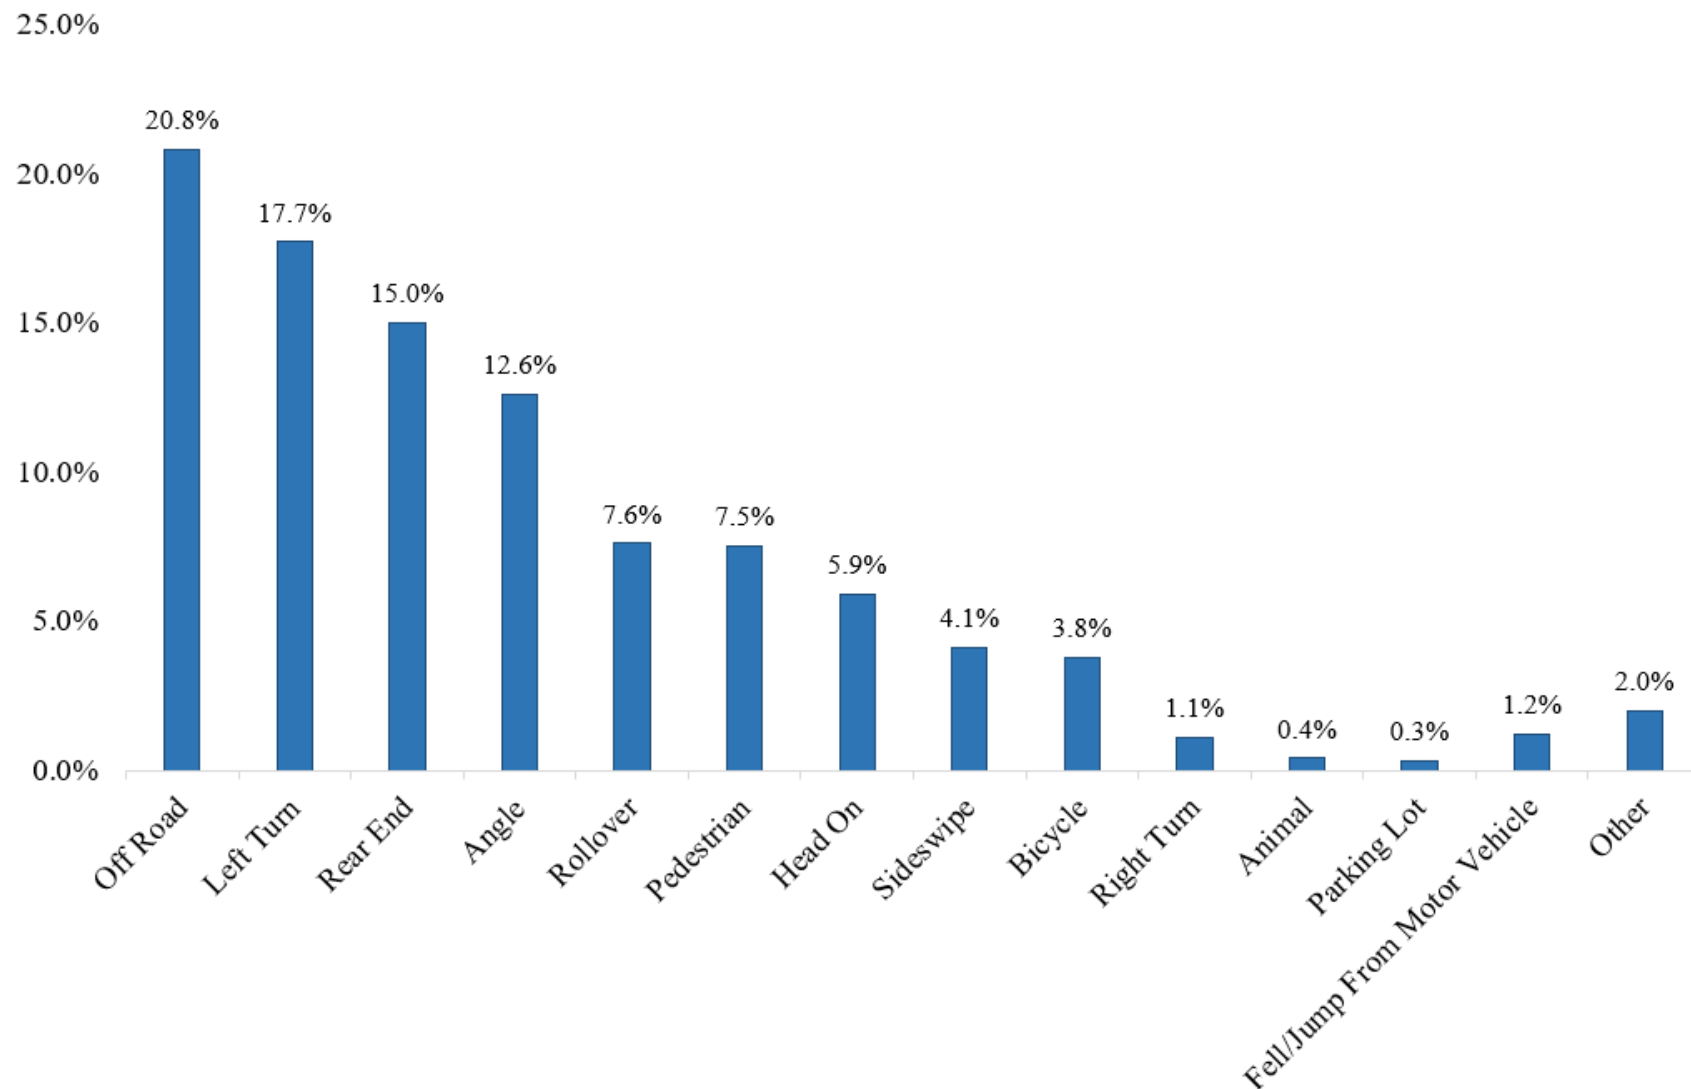
In Depth Crash Analysis 5 years (2020-2024)

Four typical crash types that causing most of severe crashes (85.0%):

- **30.3%** of the severe crashes are **left-turn/angle** crashes.
- **Off road/roll over** , rear-end, and pedestrian/bicycle crashes account for **28.4%**, **15.0%**, and **11.3%** of KA crashes, respectively.

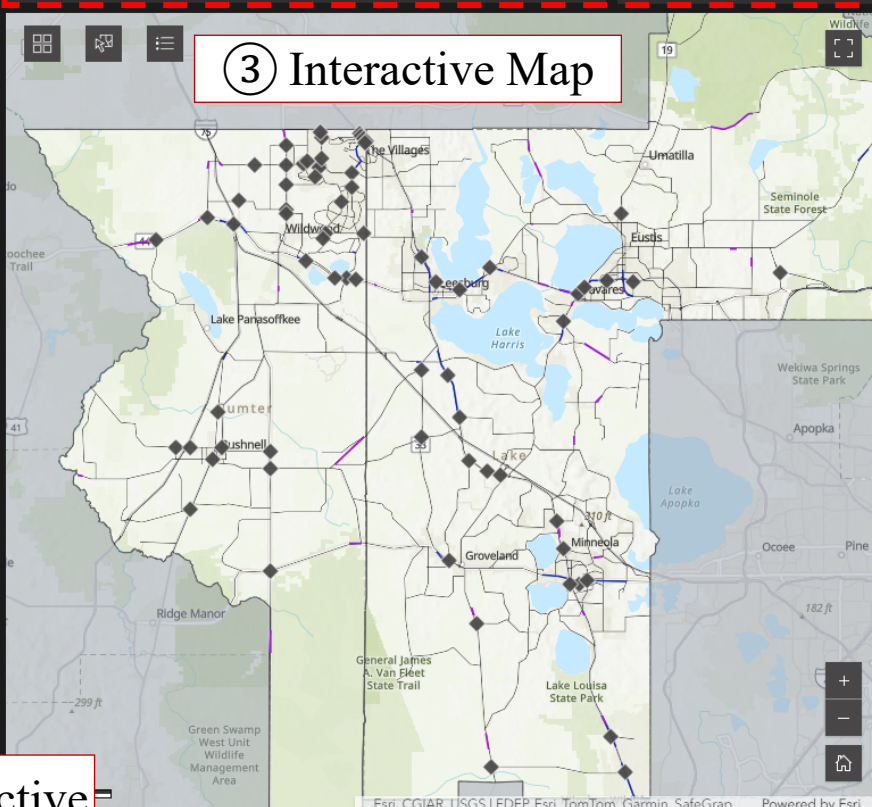
③ Interactive Map

Number of HIC
106
Number of HIS
40
Number of HII
70

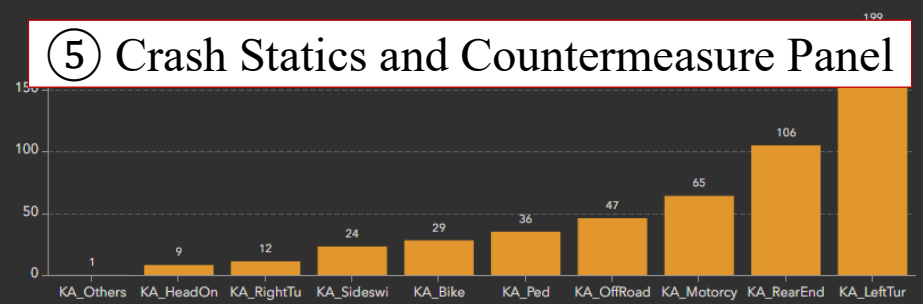
Number of KA Crashes by Crash Type

⑤ Crash Statics and Countermeasure Panel
